TECHNICAL BULLETIN TB07-2014

Regarding: Securing and sealing the switch

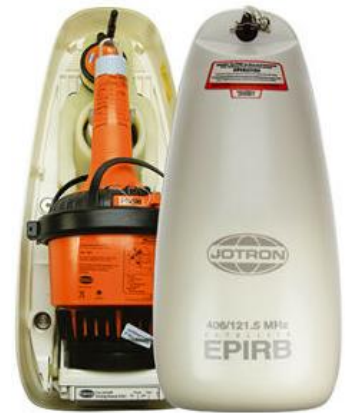
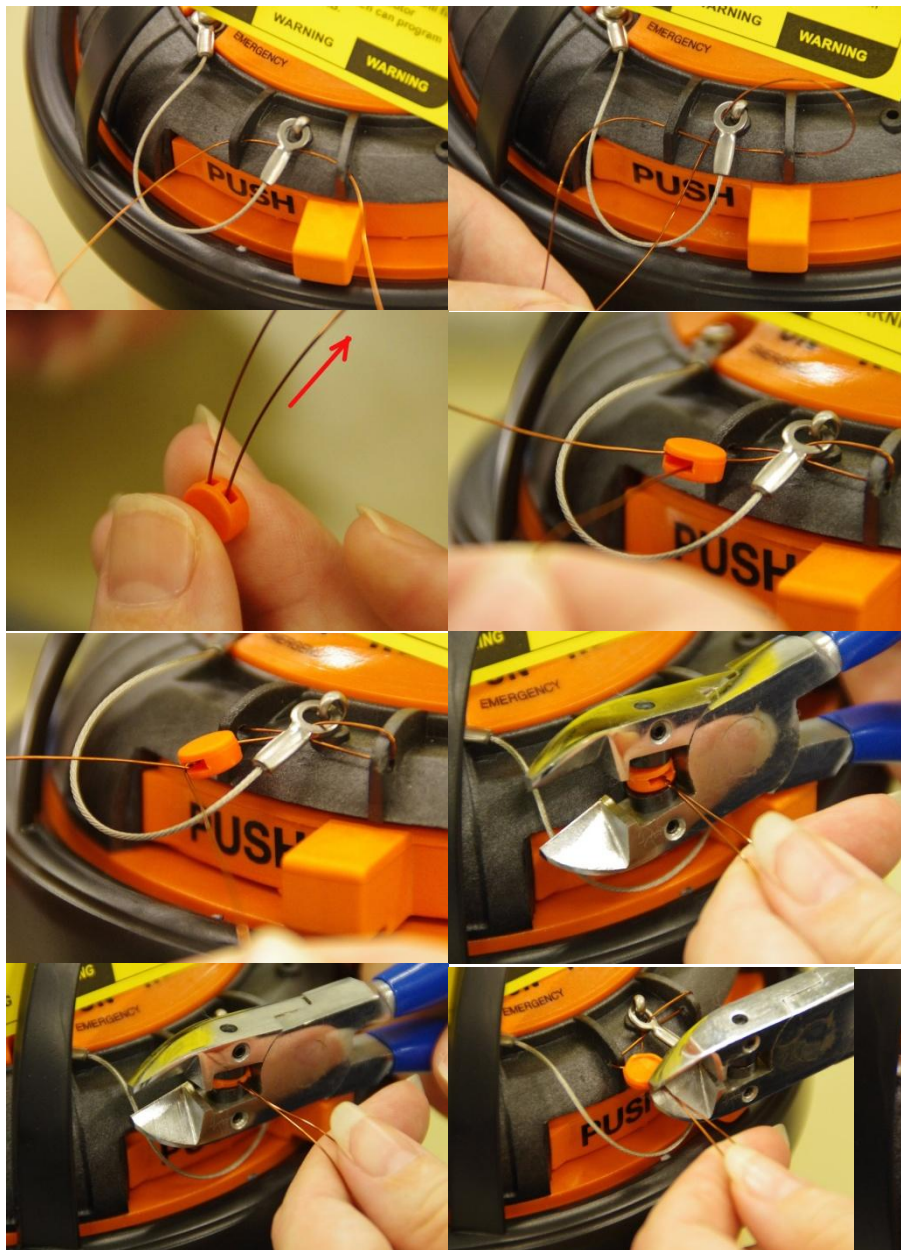
If the seal is broken and EPIRB is not activated, it may be re-sealed using the procedure below

- Thread the lacquered copper wire as shown in the two first pictures
- Thread the ends through a new seal, red arrow shows direction of the EPIRB. The end of the seal with two holes shall be pointing to EPIRB; the end with rectangular hole shall point outward.
- Twist the ends of copper wire as shown in picture
- Use special pliers to compress the seal and then cut off the ends of the copper wires
